PROPERTY CONDITION ASSESSMENT
OF
WORLD TRADE CENTER PORTFOLIO

ONE WORLD TRADE CENTER

Merritt & Harris, Inc. Project Number 20-251E

December 6, 2000

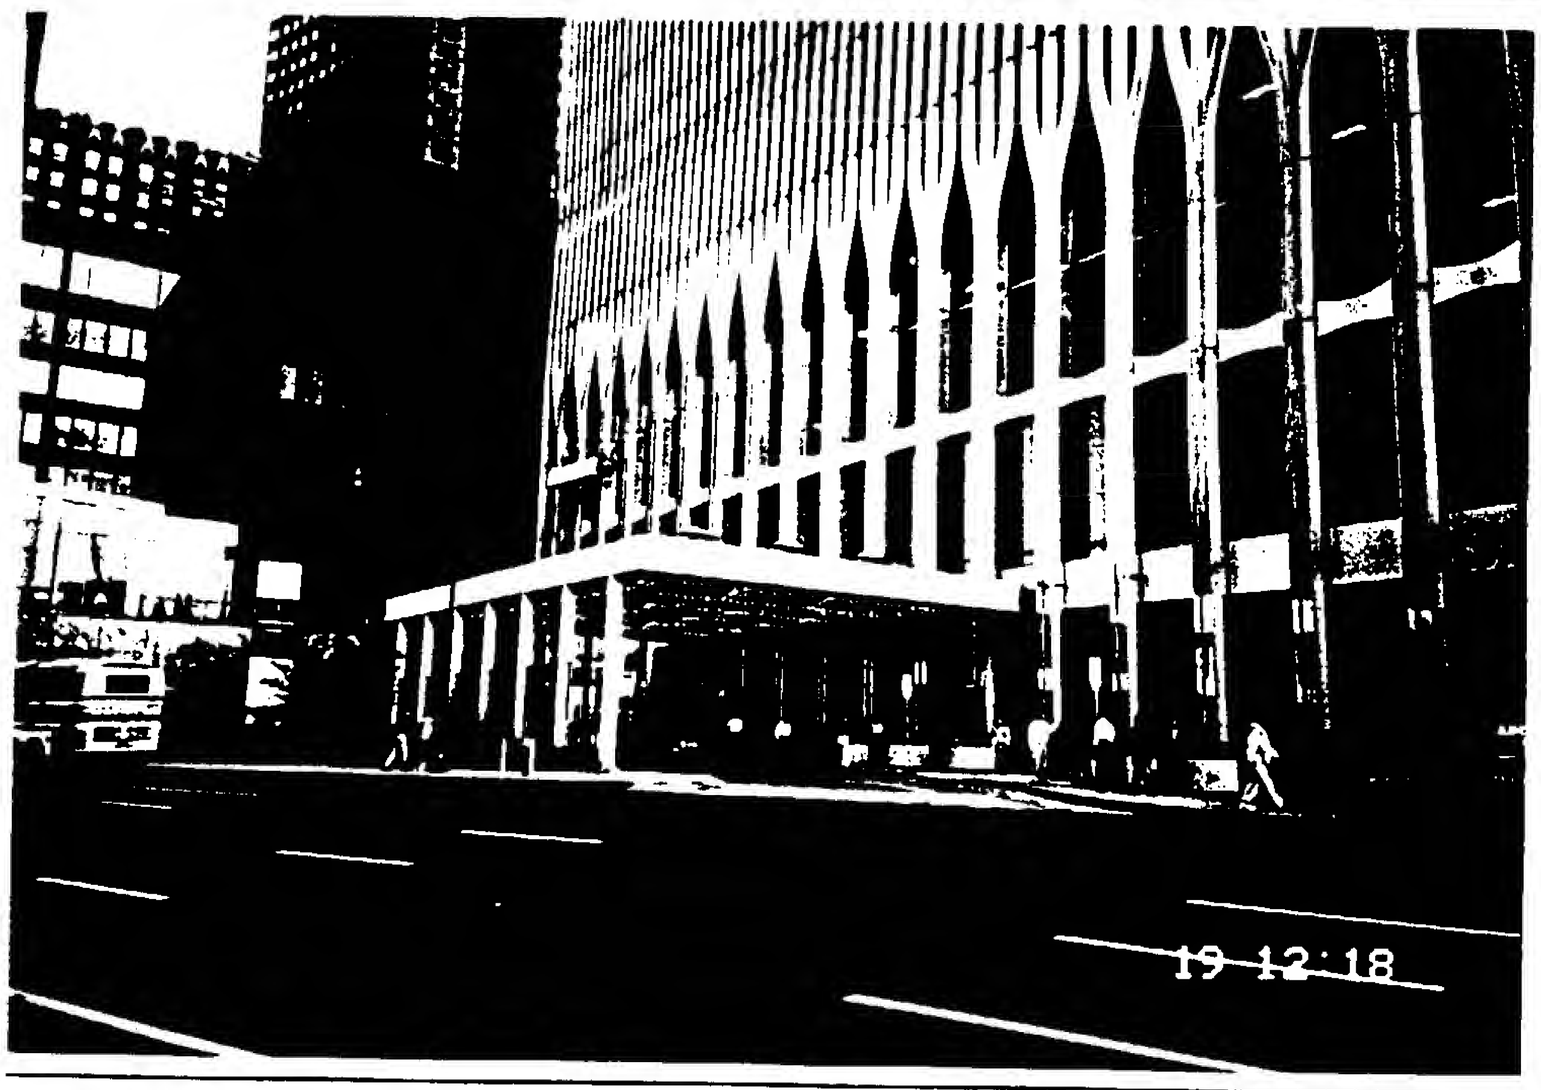
Photograph 1

Front plaza level entrance (east)

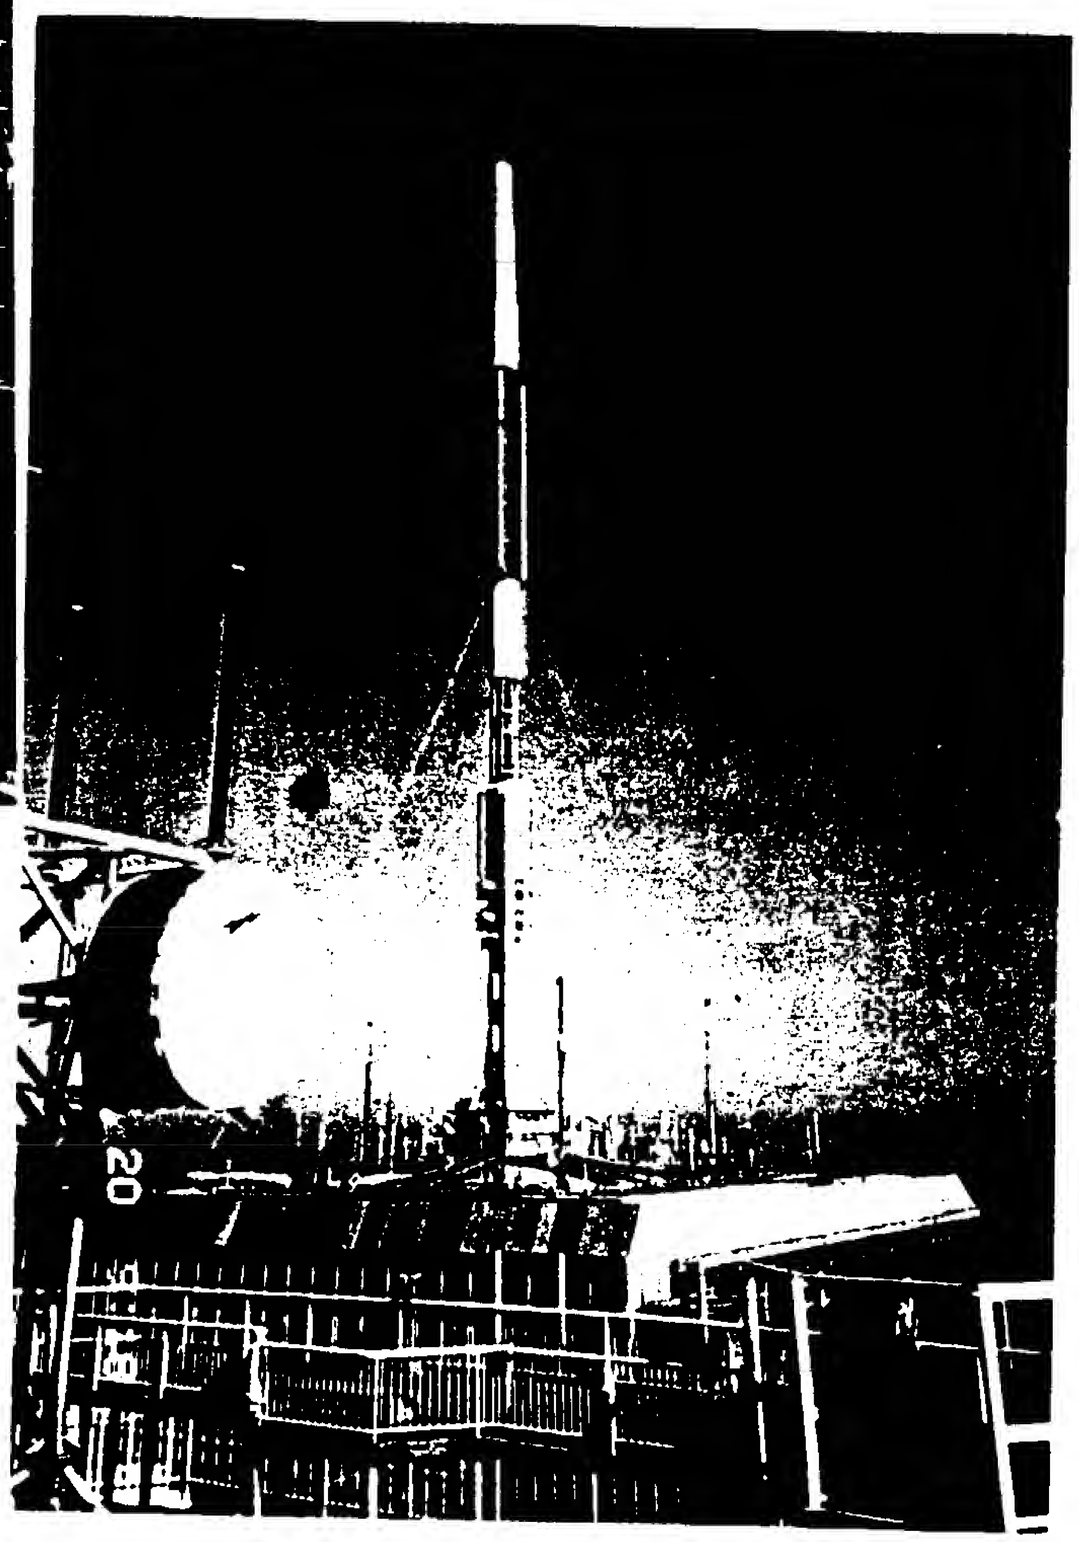
Photograph 3

Rooftop and antenna

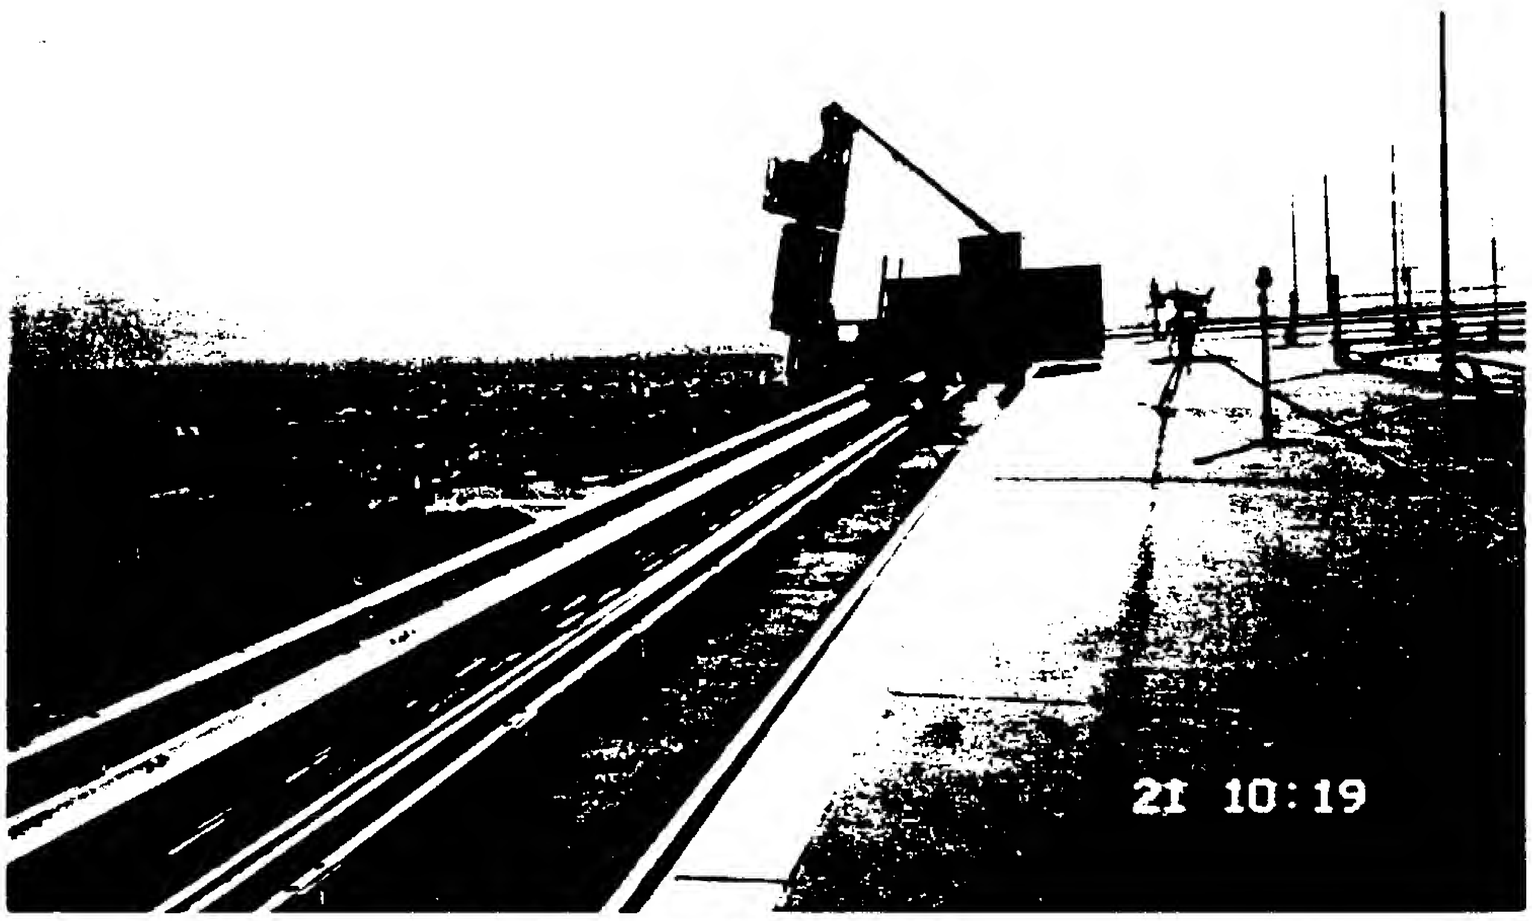
Photograph 5

Window washing rig

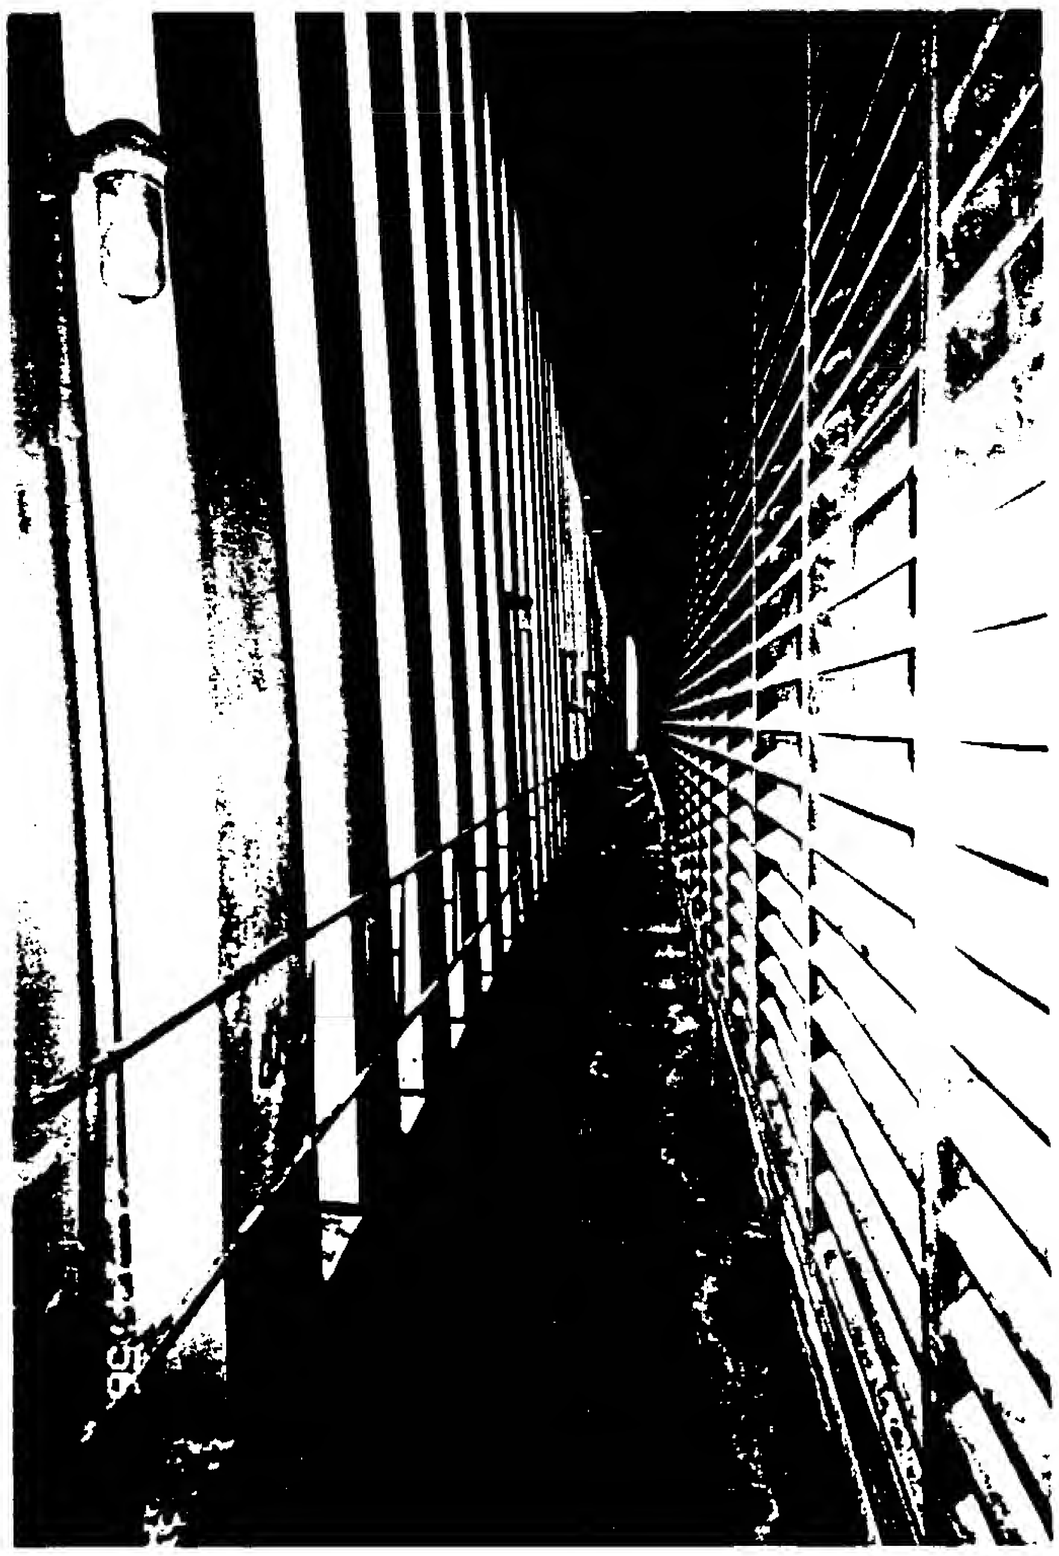
Photograph 6

Typical setback at MER levels

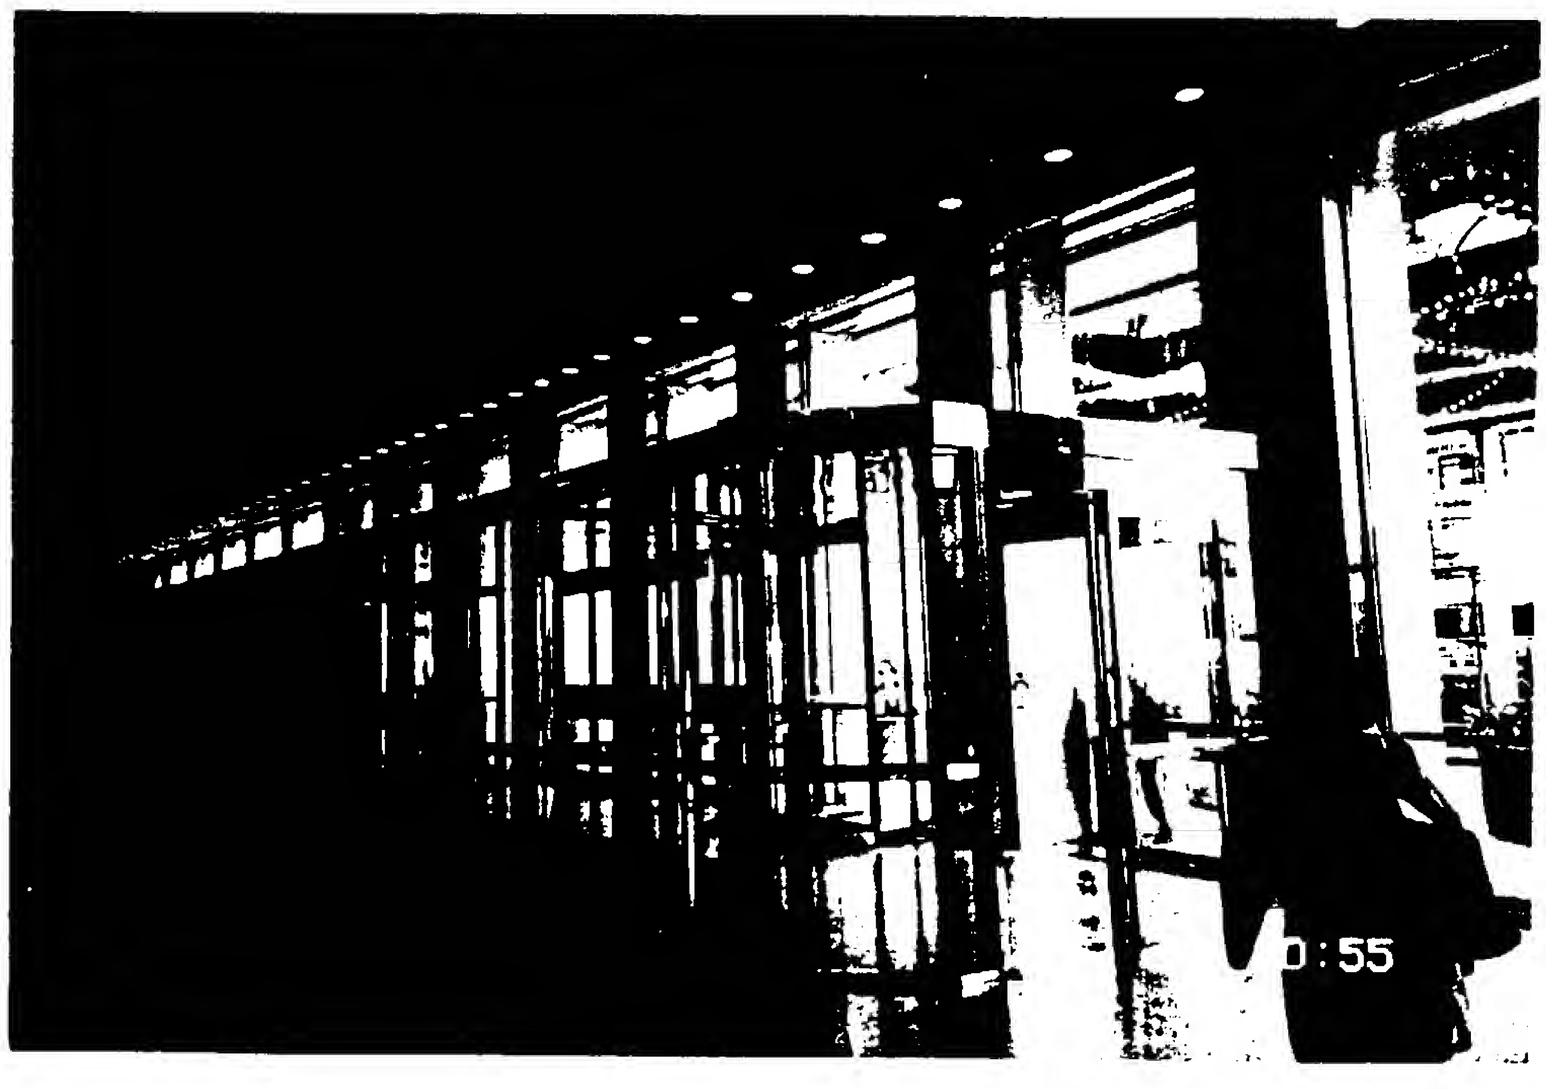
Photograph 9

Lobby entrance from mall, and escalators to mezzanine

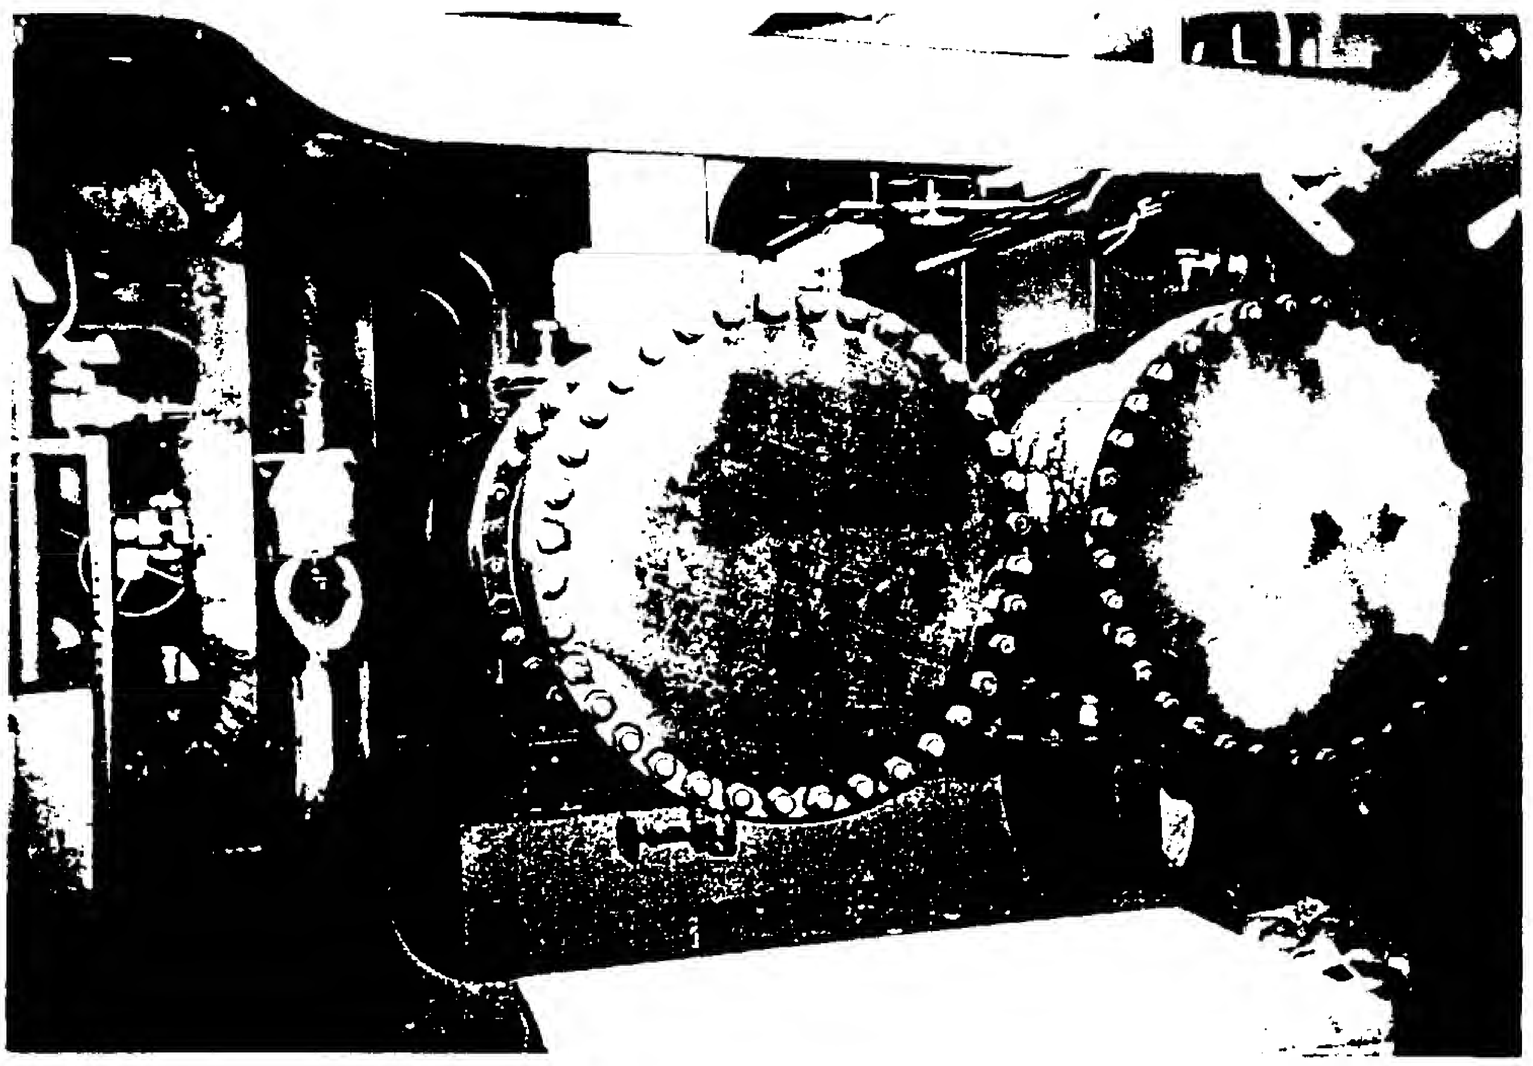
Photograph M1

Condenser water system #2 pump

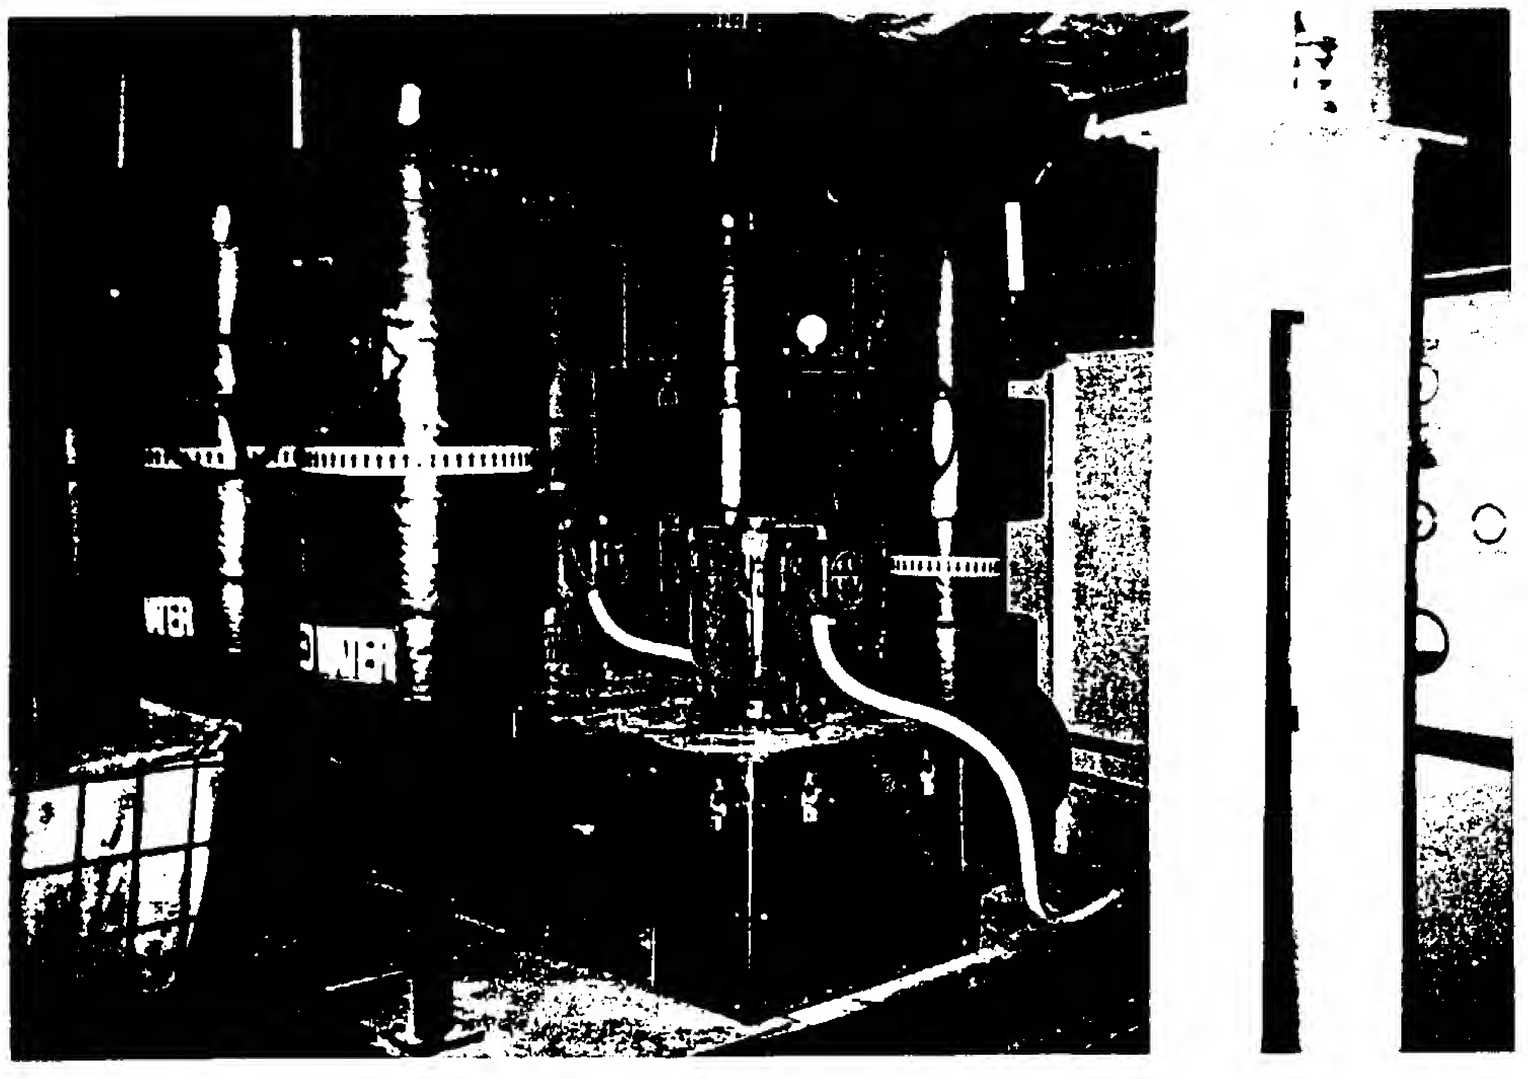
Photograph M3

New condenser water system #2 pump and plate and frame heat exchanger

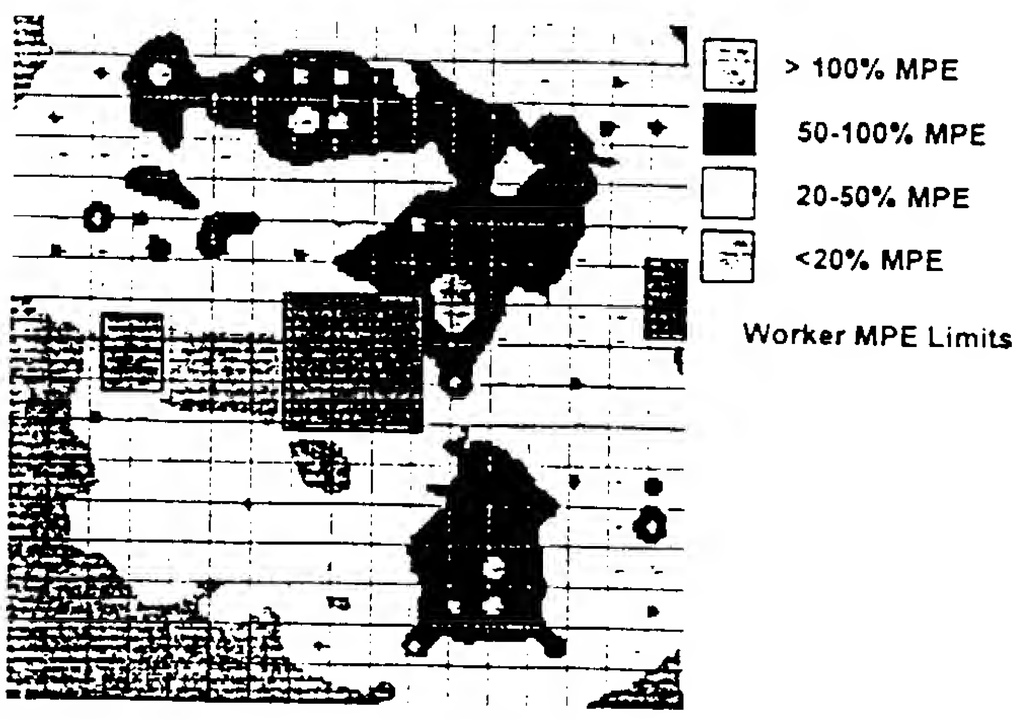
RF Survey Map of WTC North Tower Rooftop

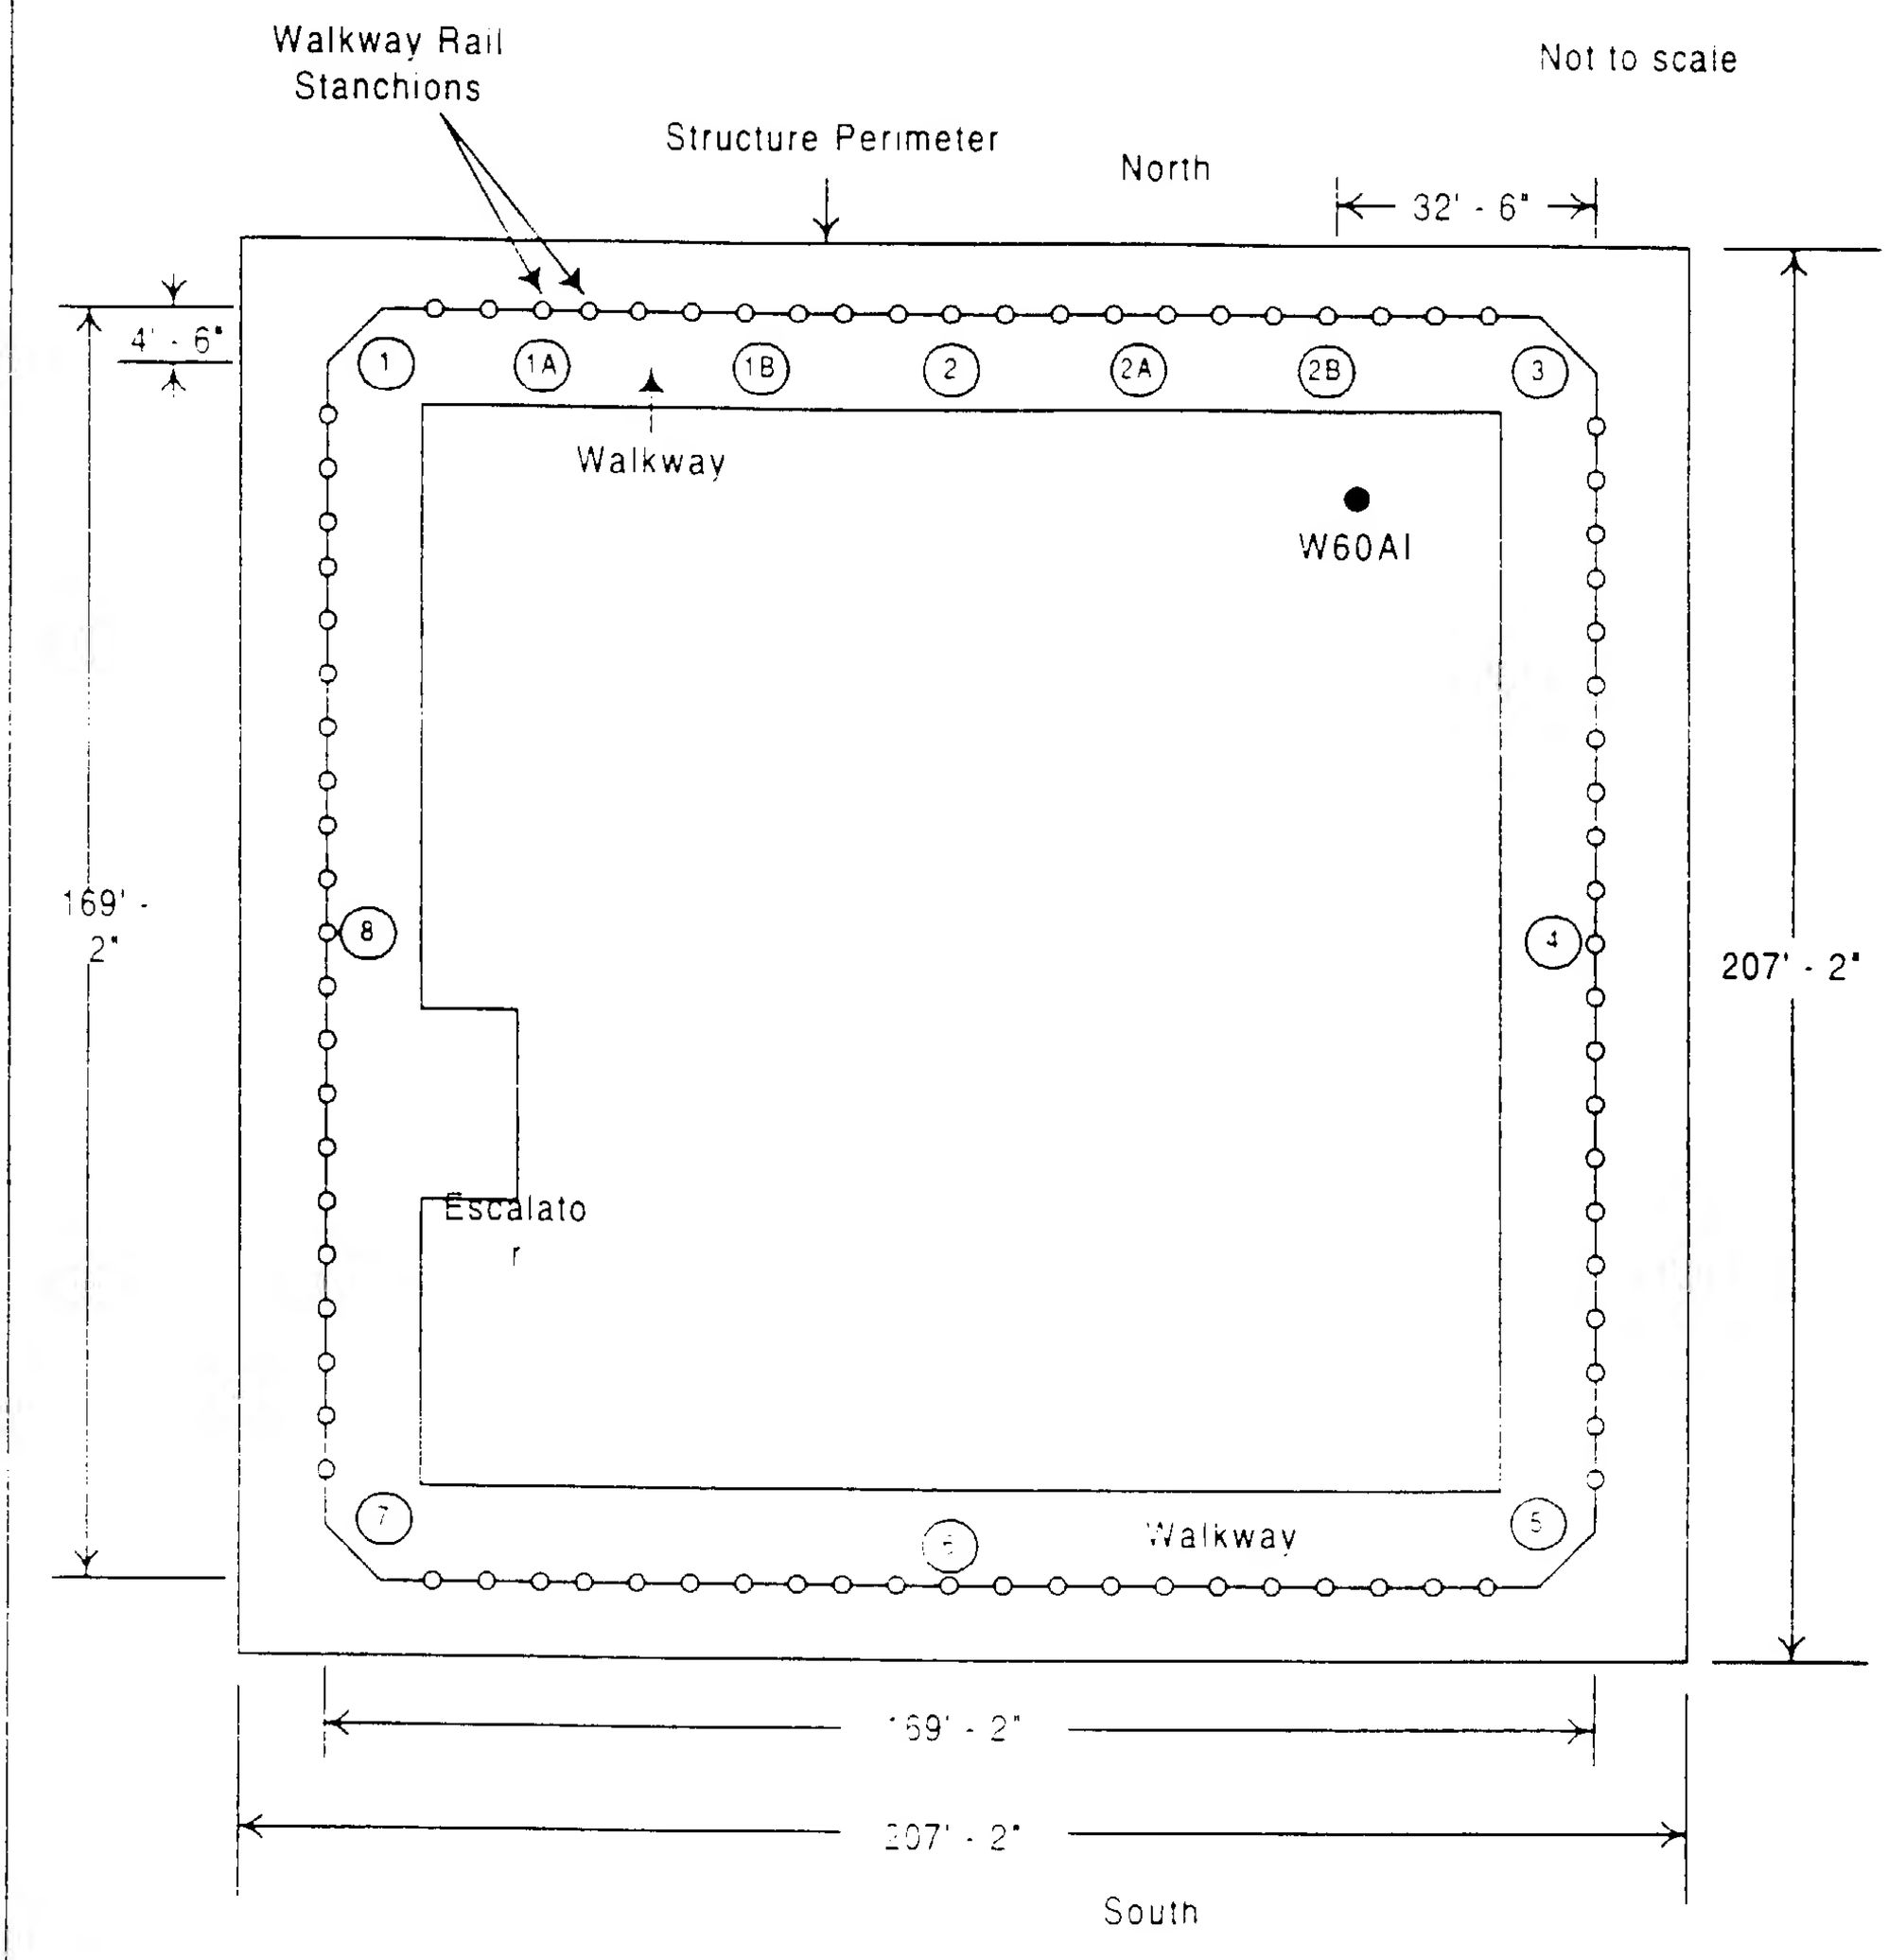
MEASUREMENT LOCATIONS
WORLD TRADE CENTER
SOUTH TOWER ROOFTOP OBSERVATION DECK WALKWAY

Notes:
1. Measurement locations are indicated by circled numbers and letters, e.g. (1A)
2. Observation deck walkway is approximately 9 feet above building roof level.

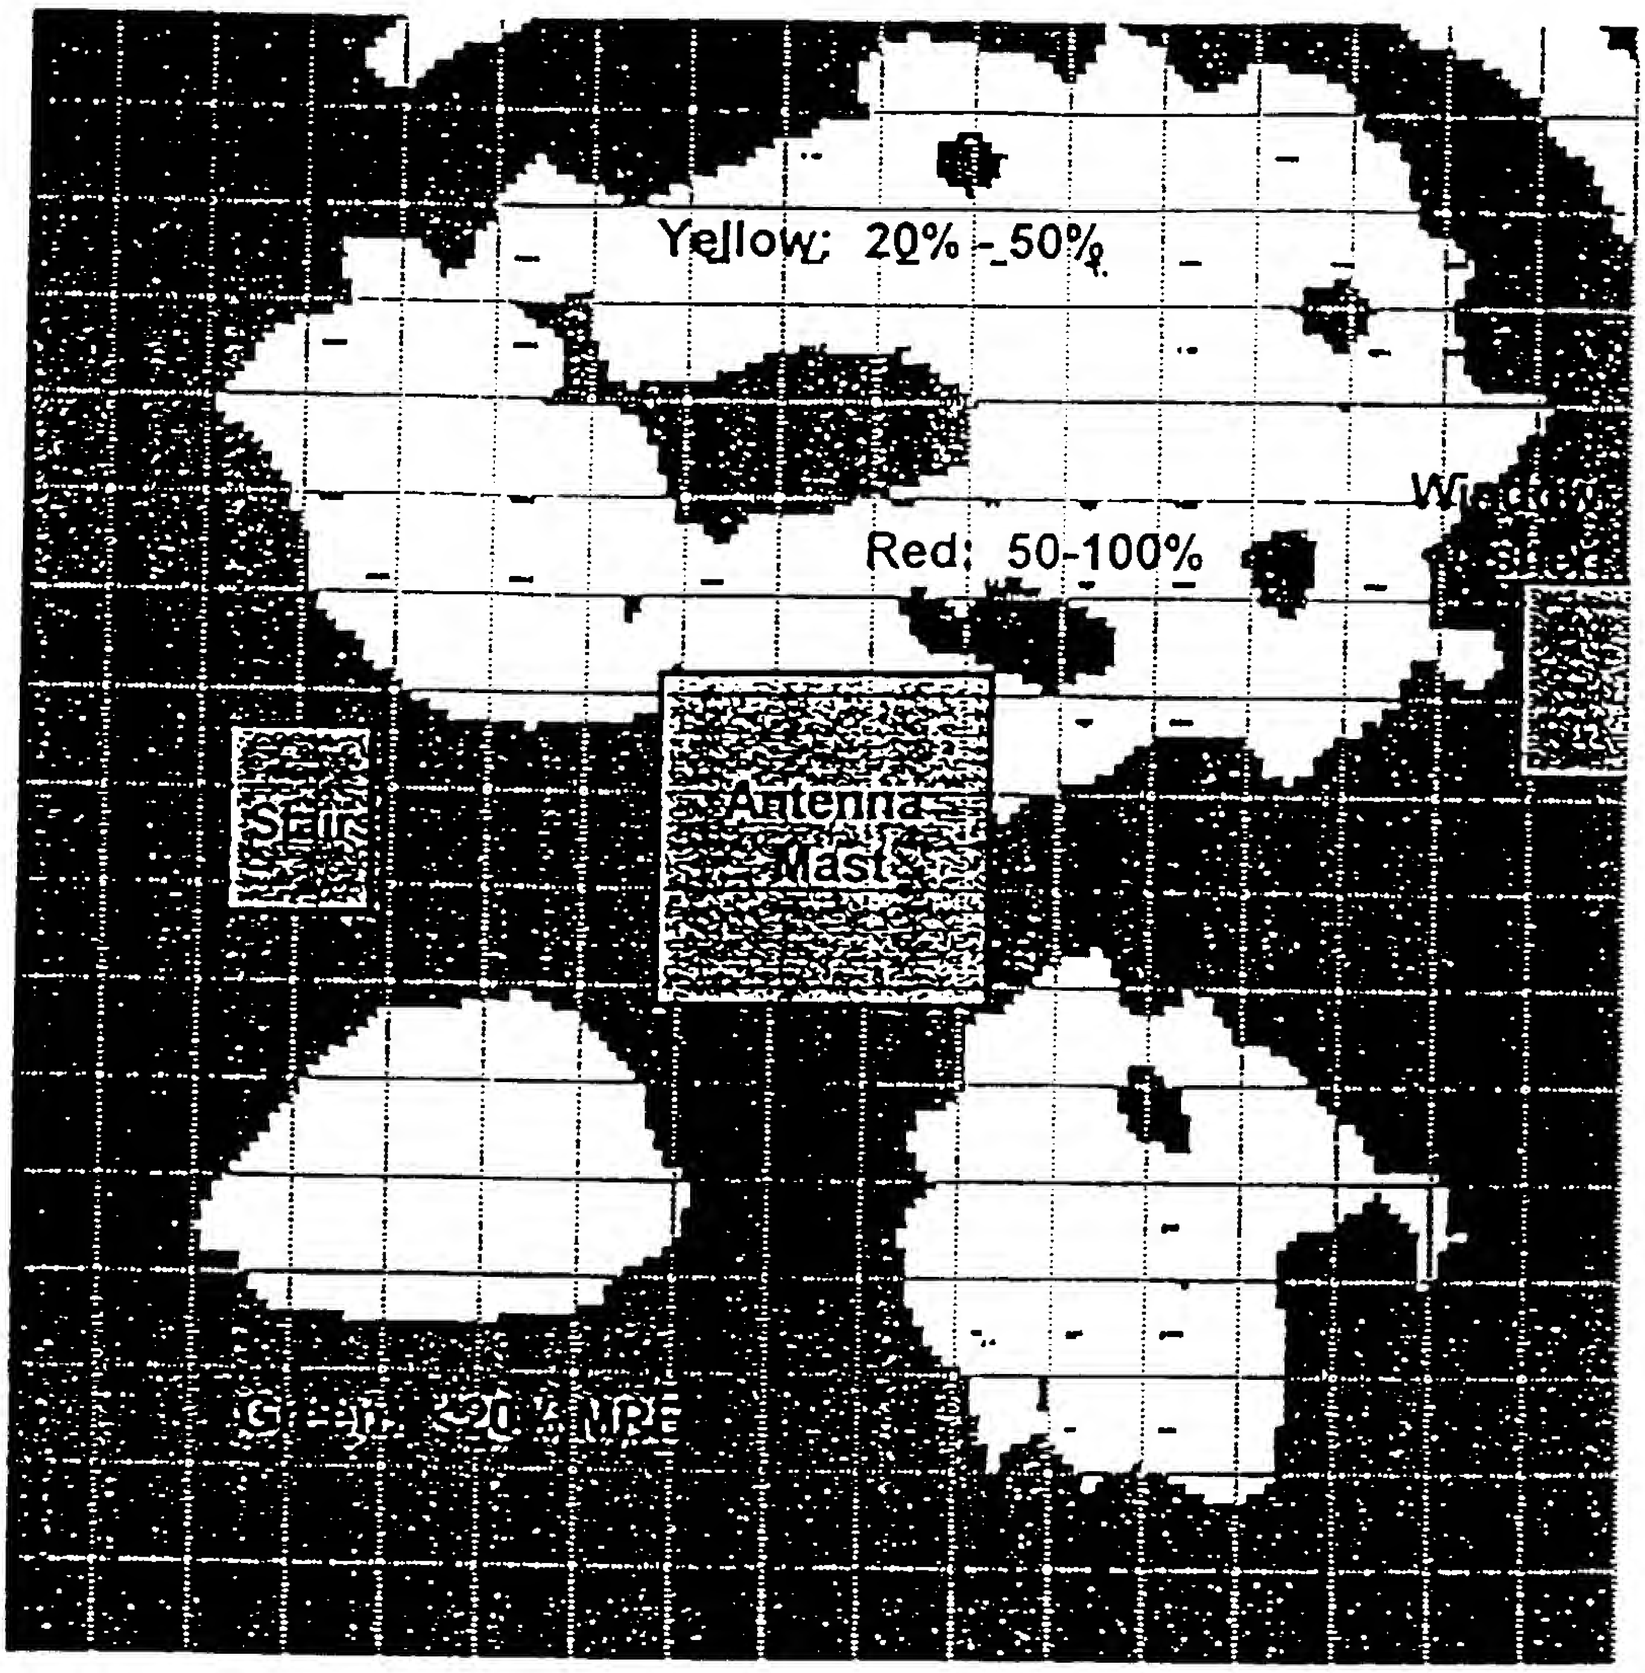
Figure 6. Roof map showing measured ambient RF fields on roof of north tower of World Trade Center during normal broadcast operations with contributions from 72 MHz paging links included Maximum field is 70 2% MPE

Statistical summary of RF Fields on WTC roof (see Figure 6)		
Percent occupational MPE range (%)	Roof area in this range (ft^2)	Percent of roof area in this range (%)
0-20	17070	62.75
21-50	9778	35.94
51-100	350	1 31
>100	0	0 00

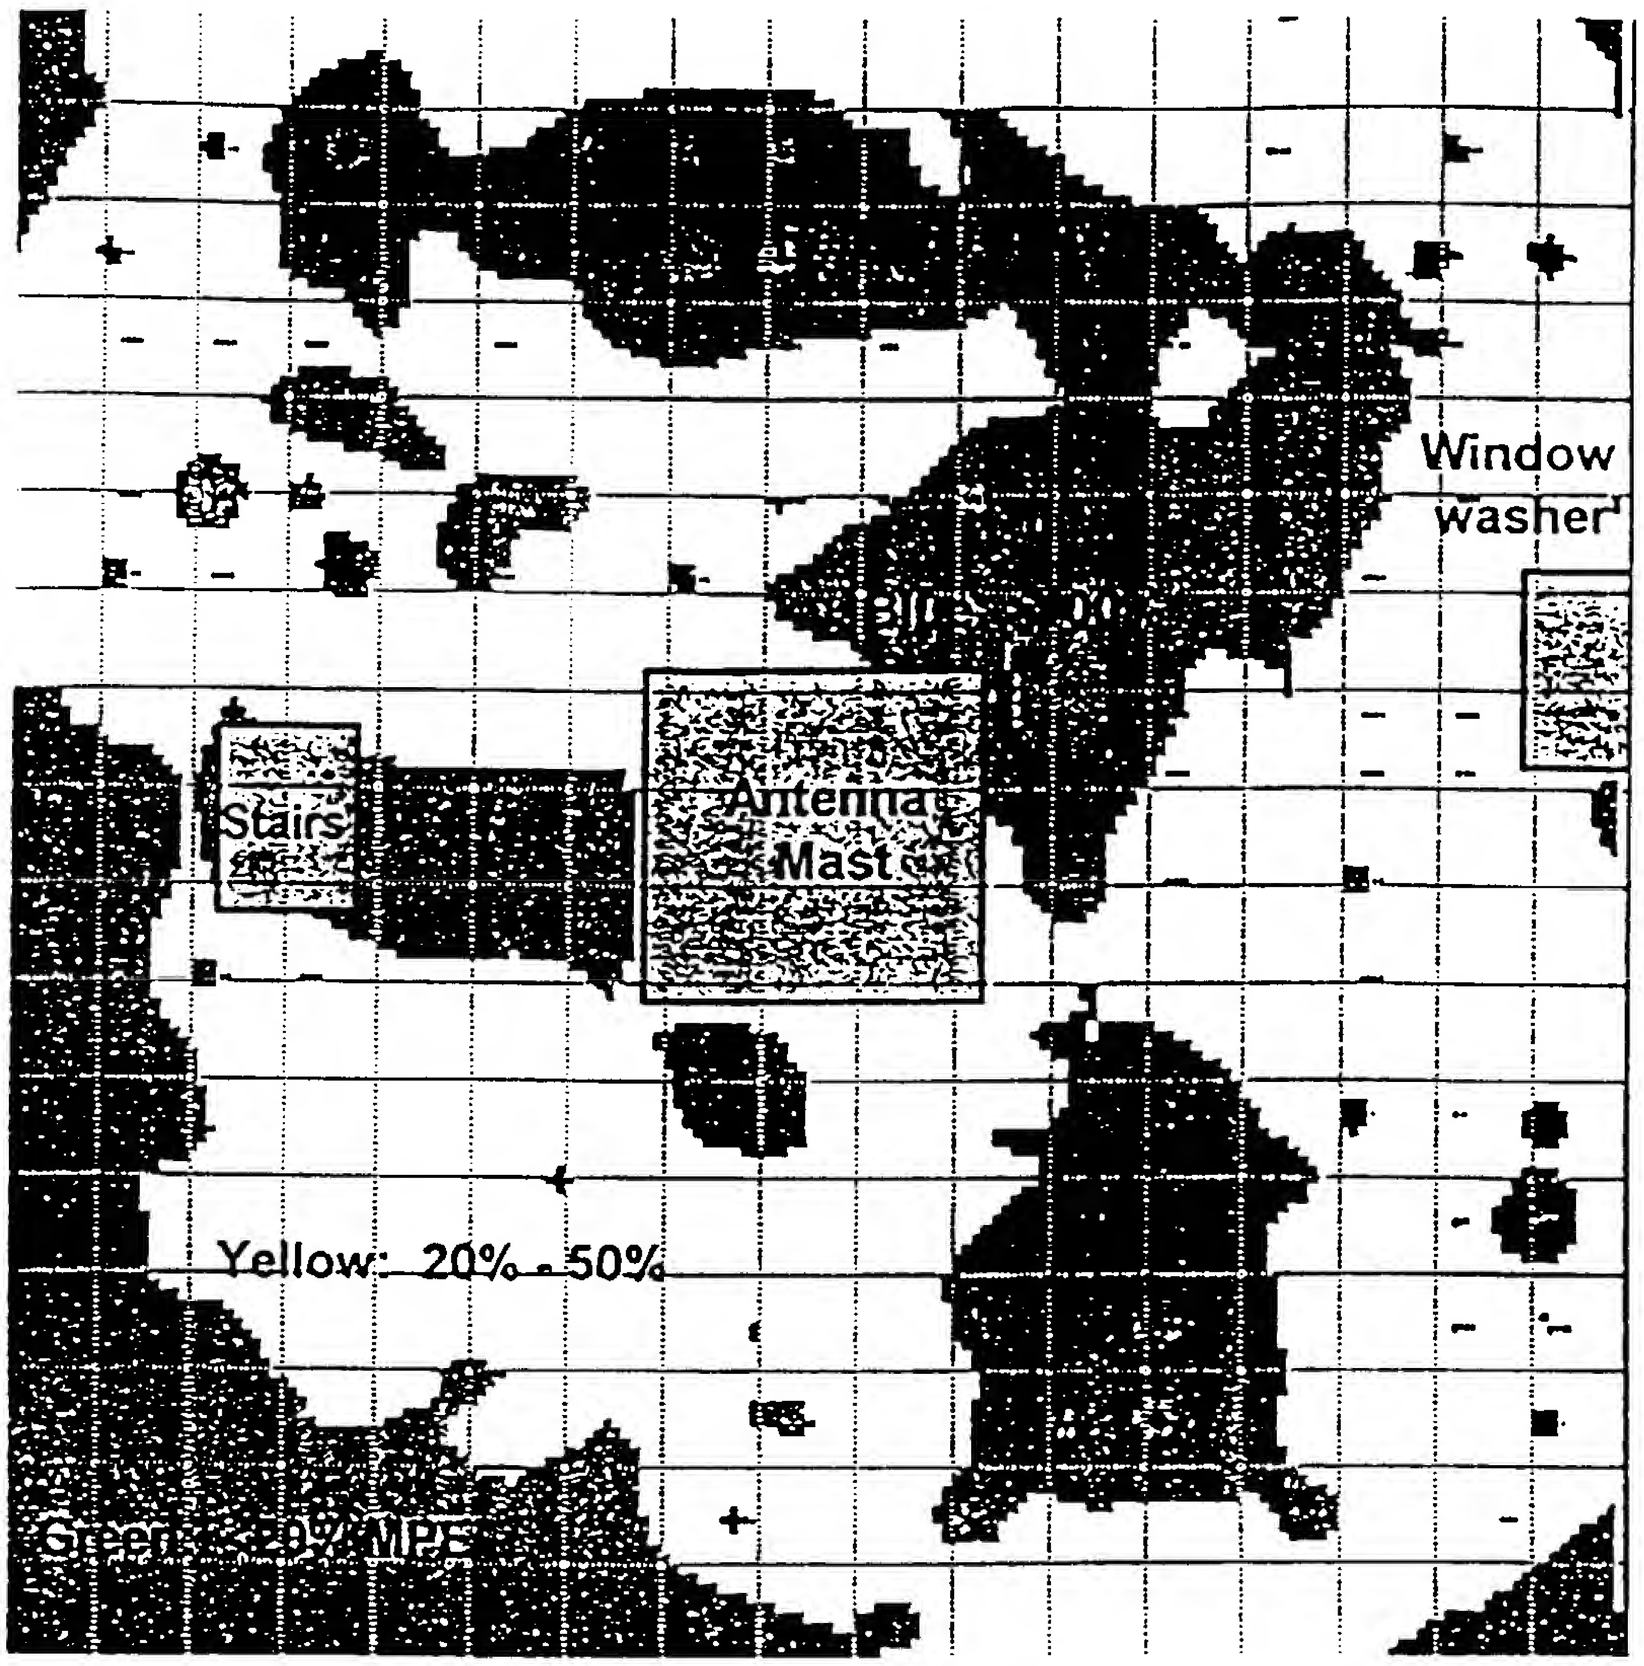
Figure 7. Roof map showing combined RF fields from measured ambient fields of normal broadcasting operations with calculated contribution of all wireless telecommunications antennas. Maximum field is 314 1% MPE

Statistical summary of RF Fields on WTC roof (see Figure 7)		
Percent occupational MPE range (%)	Roof area in this range (ft^2)	Percent of roof area in this range (%)
0-20	4502	16.55
21-50	16454	60.48
51-100	5963	21 92
>100	286	1 05
